# Safety Alert

SSC21-033

## Another accident during drilling pile foundation work

### Description of the incident

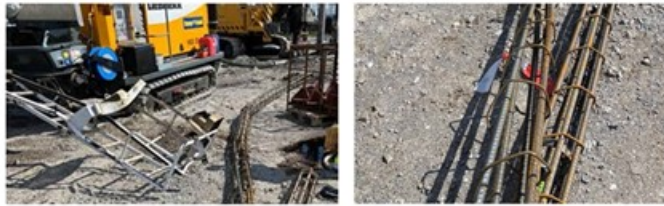
Tijdens het ophijzen van een wapeningskorf voor plaatsing in een hiervoor voorbereide paalfundering, liet een van de bovenste rondlopende en deels aan elkaar gelaste ringen, die gewoonlijk als bevestigingspunt worden gebruikt, het afweten. Vervolgens viel de korf op een gereedstaande betonwagen en trok hierbij de aan de vrachtwagen gemonteerde ladder los. Hierbij raakte een medewerker gewond.

Beschadigde graafmachine en wapeningskorf Wapeningskorf met rondlopende ringen

- Controle en herbeoordeling van de hijsprocedure, met name voor plaatsing en/of verwijdering van wapeningskorven voor boorpaalfunderingen
- Controle en eventueel aanpassing van de bevestigingsmethode, met als doel extra beveiliging in geval van falen

- Controle van de te gebruiken bevestigingspunten en eenduidige aanduiding tijdens afname van wapeningskorven
- Controle van de bevestigingspunten en juiste bevestiging met gebruikmaking van het vierogenprincipe direct voorafgaand aan het hijsen

- Eenduidige vaststelling van de gevarenszone en afgrenzing hiervan om betreding door onbevoegden te voorkomen
- Beoordeling van de geschiktheid als bevestigingspunt en vaststelling van het maximale draagvermogen, rekening houdend met de vereiste beveiligingen door de verantwoordelijke gespecialiseerde planner (eventueel fabrikant) die verantwoordelijk is voor het ontwerp en de statica van de wapeningskorf, of een gecertificeerd deskundige

Alle hijsactiviteiten voor boorpaalfunderingen waarbij hijsmiddelen aan de rondlopende ringen of het platstaal van wapeningskorven worden bevestigd, dienen tot de invoering van de noodmaatregelen te worden gestaakt.

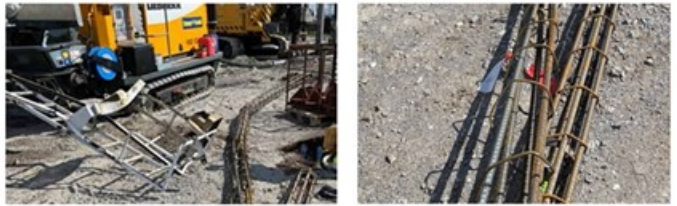
While lifting a reinforcement cage for installation in a prepared pile borehole, one of the upper rings normally used as an anchor point failed. The cage subsequently fell onto a waiting concrete truck, ripping off the ladder that was fixed to the truck. One employee was injured.

Damaged excavator and reinforcement cage Reinforcement cage with rings all around

- Review and re-evaluate lifting procedures - especially for the installation and/or removal of reinforcement cages for drilling pile foundations
- Review and, if necessary, adjust the type of lifting points, to provide additional safeguards in case of failure
- Check the anchor points to be used and clear marking when inspecting the reinforcement cages
- Check the lifting points and correct attachment by applying the 4-eyes-principle immediately before the lifting operation
- Clearly define the dangerous zone and barrier to prevent unauthorised access
- Assess the lifting points to be fit for purpose and specify the max. load capacity. The assessment must be performed by the planner (possibly the manufacturer) who is responsible for the design and the static of the reinforcement cage, or by a certified body

All lifting operations for drilling pile foundation work for which reinforcement cages are attached to rings or flat bars must be stopped until these measures have been implemented.
